Field Meeting Report: Building stones in the churches and church yards of the Stretton Hills, led by David Pannett and Andrew Jenkinson, 15th May 2004

ROSENBAUM, M.S. (2006). Field Meeting Report: Building stones in the churches and church yards of the Stretton Hills, led by David Pannett and Andrew Jenkinson, 15th May 2004. *Proceedings of the Shropshire Geological Society*, **11**, 5-11. The field excursion which met at Craven Arms on May 15th 2004 focused on the Stretton Hills. This area is well known for its complex geology and associated landscape patterns, reflected in the choice of building stones. Geology and local history have made each of the churches different, but they nevertheless reveal some common trends. Three of them (St Laurence Church Stretton, St James Cardington, and St Peter Rushbury) still have Norman naves built of locally derived rubble, later modified by better quality stone such as that from Grinshill. Meanwhile, the church of St Margaret at Acton Scott persevered in its use of the stone won from its own local and unique outcrop of Ordovician Acton Scott Limestone.

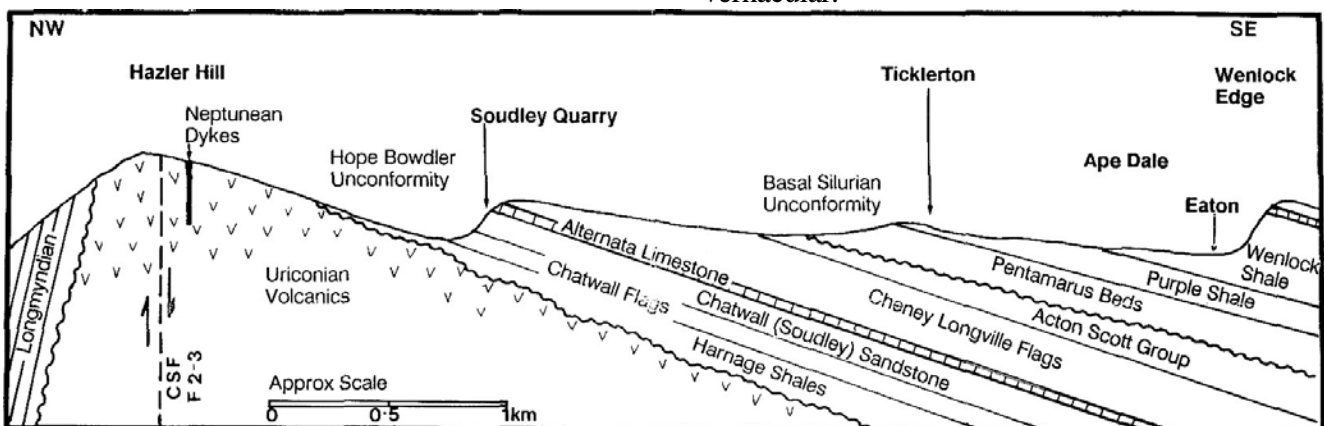
Figure 1. Geological cross-section E-W through the Stretton Hills.

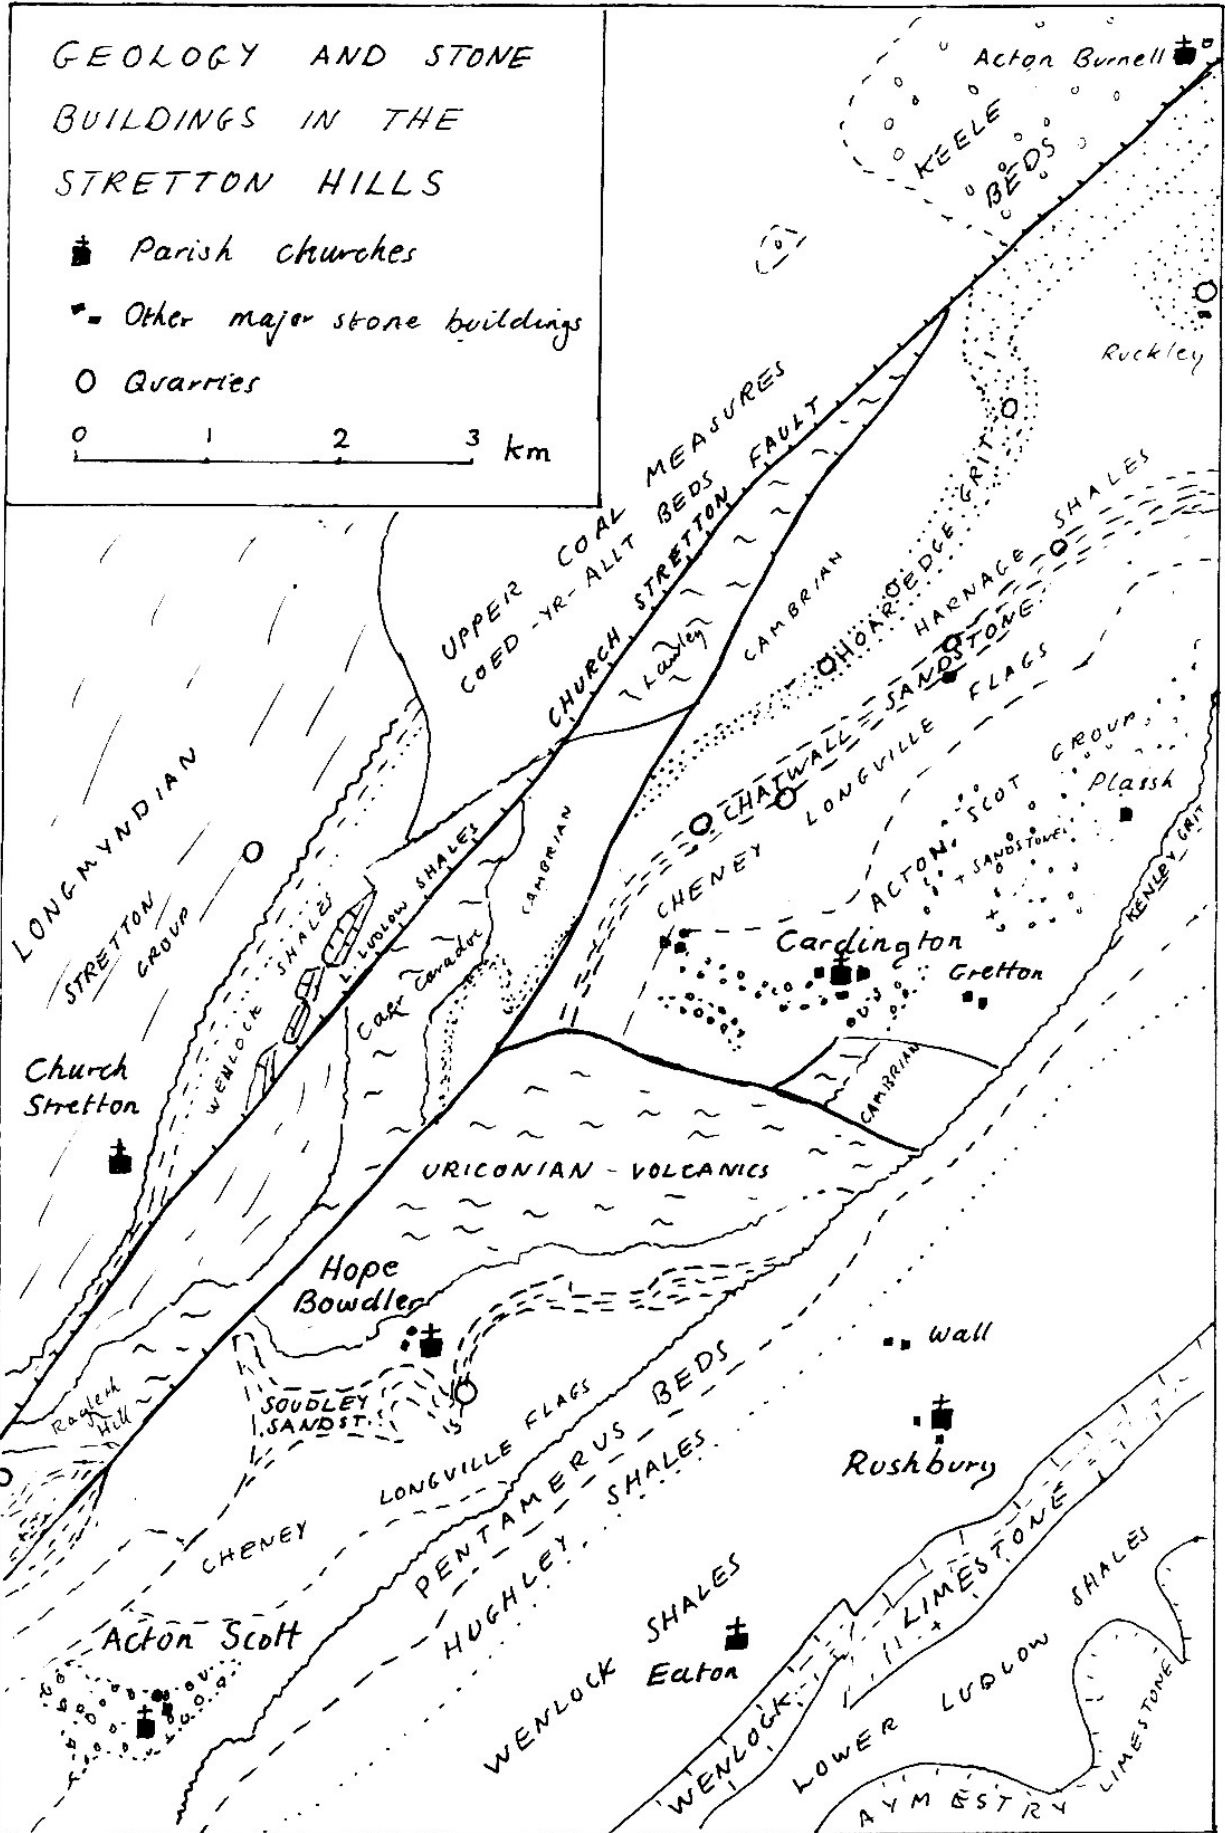
Figure 2. Geological sketch map of the Stretton Hills, showing locations of the churches mentioned in this paper.

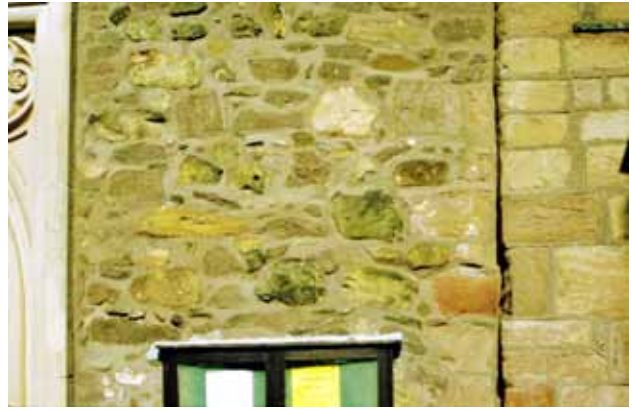
Figure 4. Mixed rubble stone. West front, St Laurence Church Stretton.

The first task set the participants was to identify as many different building stones as possible. The basic terminology was explained: rubble (rough stone) (Figure 4), coursed (layered), ashlar (shaped, with neat faces), jamb (margin of door), pilaster (corner) and quoin (edge).

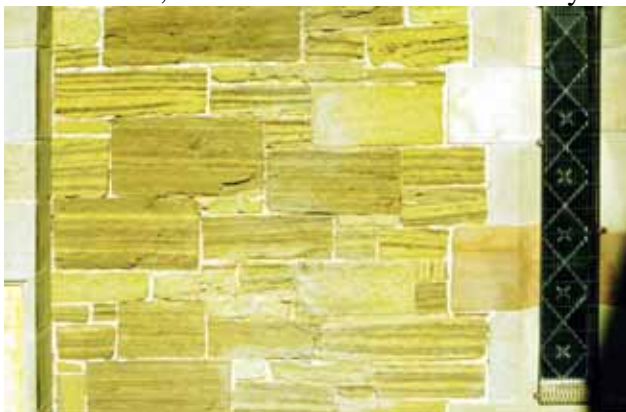
Figure 5. Soudley Sandstone. Northern transept, St Laurence Church Stretton.

The pale grey Grinshill Sandstone is of Triassic age, but the ashlar here is predominantly of Soudley Sandstone, a distinctive banded grey/green and dark red rock of Ordovician age worked for a long time at Soudley, and

The characteristic banding of the Soudley Sandstone caused much discussion. The shapes of the distinctive banded grey/green and dark red alternations were reminiscent of cross-bedding (Figure 5). The red colouration appeared to be due to oxidation of iron minerals within the sandstone, which might well be diagenetic or due to groundwater migration, or might relate to bacterial attack on organic matter within the original sediment. Close examination suggested that the initial colouration may have been yellowish brown. The red brown colouration is later and appears to be associated with calcite. The green colouration may be organic-rich or clay-rich, facilitating reduction of the iron minerals, or perhaps it is just due to calcite depletion.

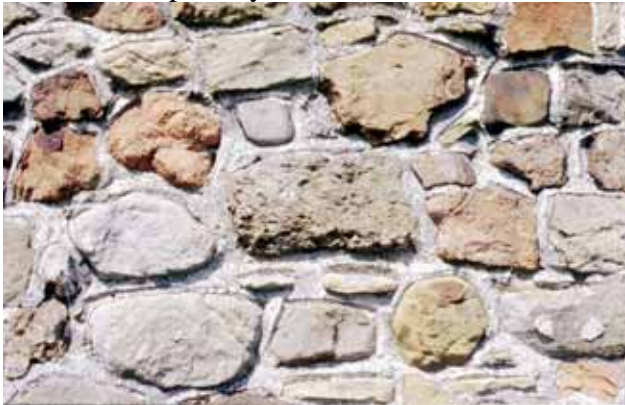
Figure 6. Geological mixture in Norman wall, Cardington Church.

(Figure 6); examples included: Uriconian volcanics, Cambrian Wrekin Quartzite, Ordovician Hoar Edge Grit (yellowish coarse grit stone) and Cheney Longville Flags (grey sandstone), Silurian *Pentamerus* Beds (shelly limestone), and various glacial erratics (mostly dolerite, but one piece of red granophyre was observed, probably Eskdale "Granite"). Jambs and quoins are predominantly made of Hoar Edge Grit (white sandstone). The 13th Century chancel to the west is more uniform, predominantly Hoar Edge Grit (Figure 7). However, restoration has employed Grinshill Sandstone, especially notable in the windows.

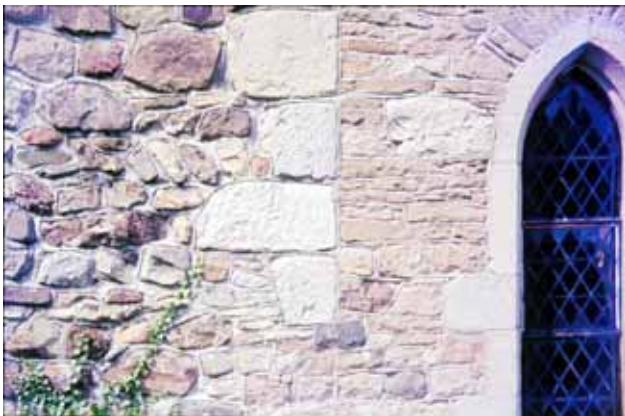
Figure 7. Predominantly Hoar Edge Grit. Norman nave left, 13th Century Chancel right; Cardington Church.

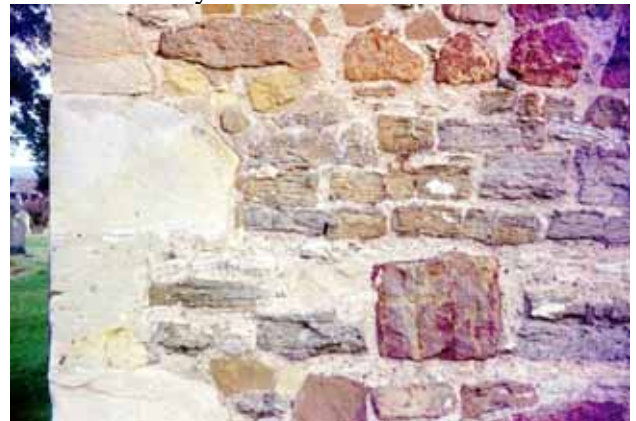
Figure 8. Rushbury Church, revealing Soudley Sandstone, Wenlock Limestone and possibly Hoar Edge Grit.

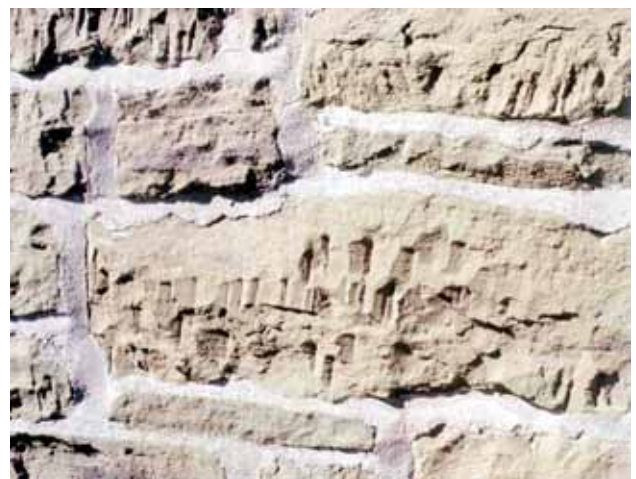
Figure 9. Rushbury Church, revealing Soudley Sandstone with 19th Century tool marks - 'rustication'.
